**STRUCTURAL HEALTH INSPECTION OF EXISTING STRUCTURE (GROUP
HOUSING BUILDING) NOIDA SECTOR xxx, UTTAR PRADESH**

DOC. NO. SEPT/2024/SSI/4

STRUCTURAL HEALTH ASSESSMENT USING NON-DESTRUCTIVE TESTING AND VISUAL INSPECTION

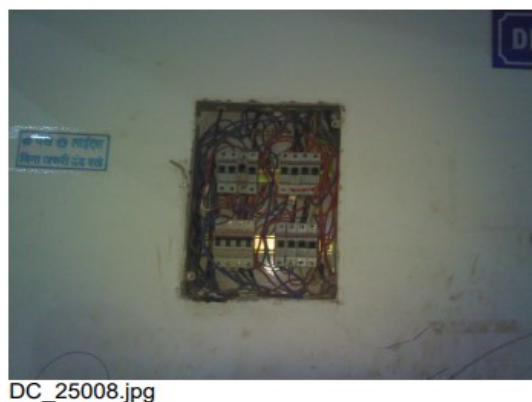
Bx1	Max	27.0 °C
	Min	26.6 °C
	Average	26.8 °C
Bx2	Max	27.1 °C
	Min	26.6 °C
	Average	26.8 °C
Dt1	Bx2.Max - Bx1.Max	0.1 °C

LOCATION	INSIDE WAREHOUSE, F&V AREA, LDB
Risk Category	NORMAL

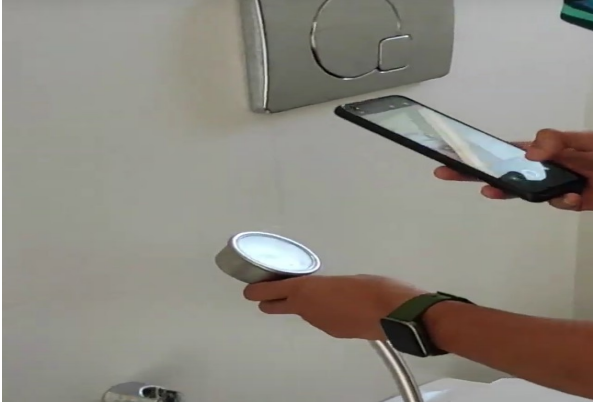
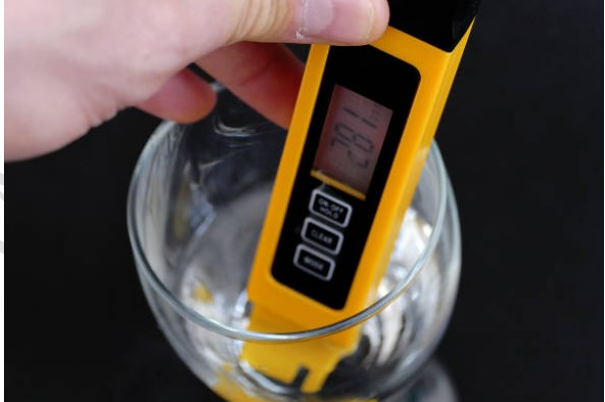
Water Pressure Check	Water TDS Check

Table Quality Assurance in Concrete using Non Destructive Testing			
Client:- M/s		Consultant :- SafeSence	
SL. No.	Sample Identification	TDS in mg/L	Water Pressure in PSI
GROUND FLOOR			
1	Kitchen Sink	125	40
2	Toilet Basin	175	42
3	Toilet Jet	135	44
4	Balcony Tap	150	40
5	Wash Basin	180	44

Result:- The TDS of water is ok and safe to use.

The water pressure is ok and no need to install any additional pump near tank.

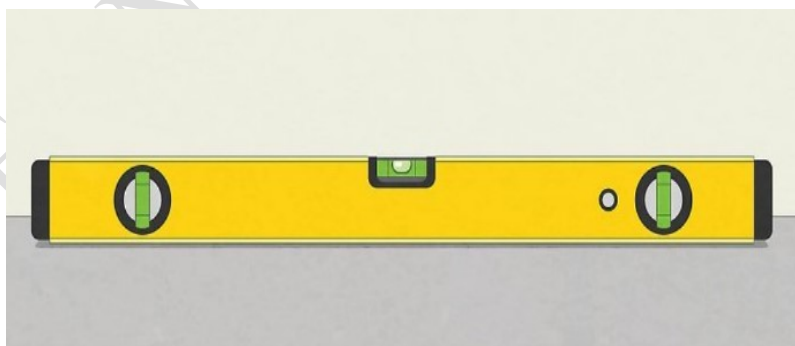
Floor level checking instrument

- 1. Set a 4–8 ft (1.2–2.4 m) spirit level horizontally on the floor:-** Pick a spot in the middle of the floor or against one of the walls. Lay a spirit level horizontally, so that the bubble is on top. Check the level by laying it on a surface, noting where the bubble in the middle is, flipping it over one end, and seeing if it's in the same place.

- 2. Look where the bubble rests to see if the floor is sloping:-** If the bubble isn't in the lines in the middle, the floor isn't level. When the bubble touches the sides of the lines, it's off about 1 inch (2.5 cm) per 4 feet (1.2 m), sloping down in the opposite direction of the bubble.

- 3. Check for gaps and bumps underneath the level:-** Get down on the floor by the level and check if the bottom edge rests completely flush on the floor. Measure the depth of the dip from the level, or check the slope by lifting one end of the level until the bubble is centered and measuring the height of the raised end.

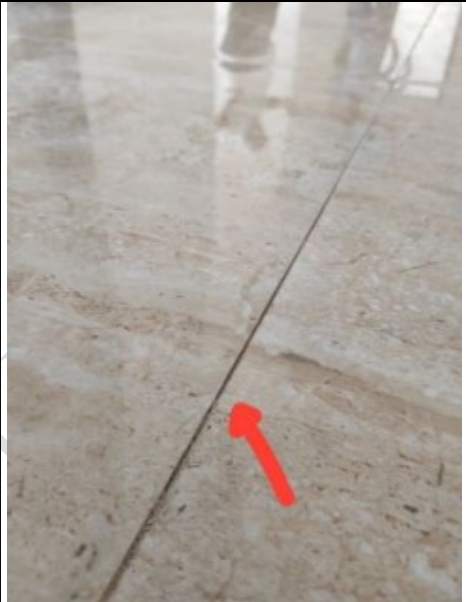
Levelling check				
Sr.No.	Observation/ Reading	Identification	Impact	Photo
1	Uneven floor settlement at various locations	Living Room	High

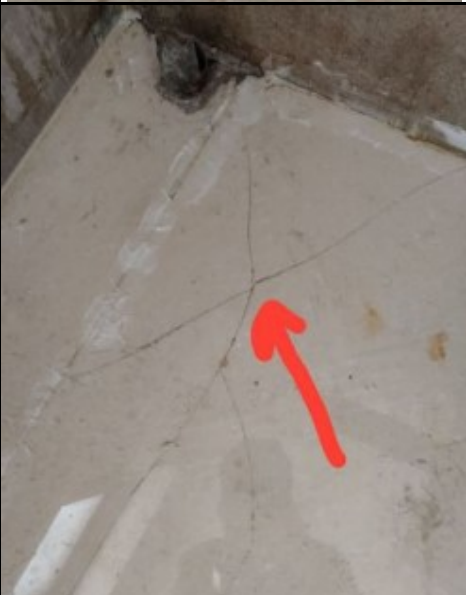
2	Damage tile and gap between tile and pipe junction	Toilet	High

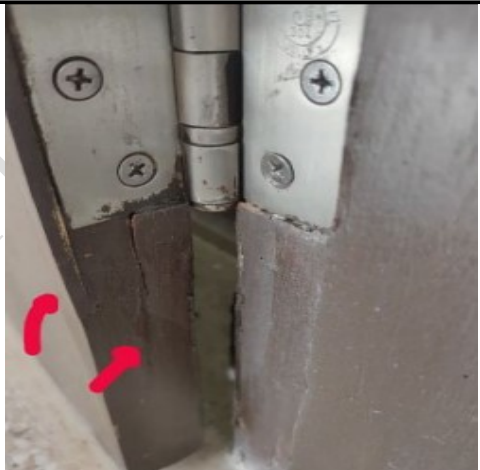
Door & window check				
Sr.No.	Observation	Identification	Impact	Photo
1	Door needs to be pushed to lock	Living Room	High
